Defence Science and  
Technology Group

# The PC9A Filter Screening Tool

DST-Group-TR-3210

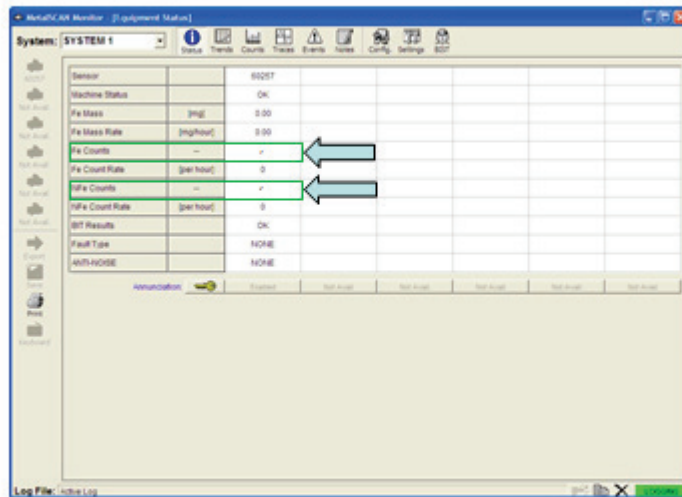
SYSTEM 1	
Sensor	60257
Machine Status	OK
Fe Mass	[mg]
Fe Mass Rate	[mg/hour]
Fe Counts	0
Fe Count Rate	[per hour]
NFe Counts	0
NFe Count Rate	[per hour]
BIT Results	OK
Fault Type	NONE
ANTI-NOISE	NONE

Status screen of MetalSCAN software

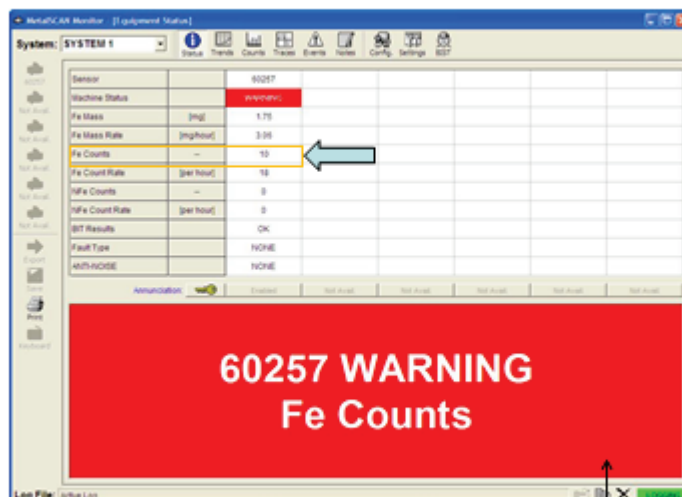
SYSTEM 1	
Sensor	60257
Machine Status	Warning
Fe Mass	[mg]
Fe Mass Rate	[mg/hour]
Fe Counts	10
Fe Count Rate	[per hour]
NFe Counts	0
NFe Count Rate	[per hour]
BIT Results	OK
Fault Type	NONE
ANTI-NOISE	NONE

**60257 WARNING  
Fe Counts**

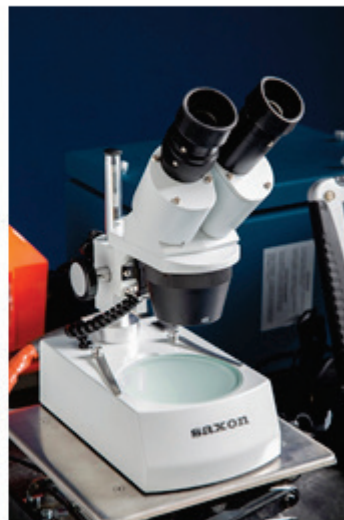
X40

X40 is the only magnification to be used

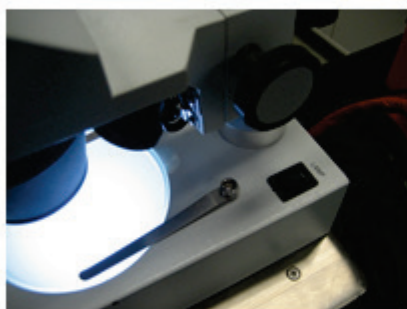
Position "I" Back Lit  
(Glass Bead)

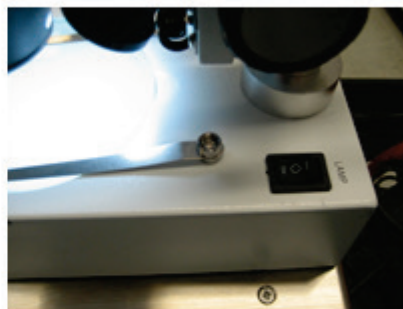
Position "II" Top Lit  
(Bronze)

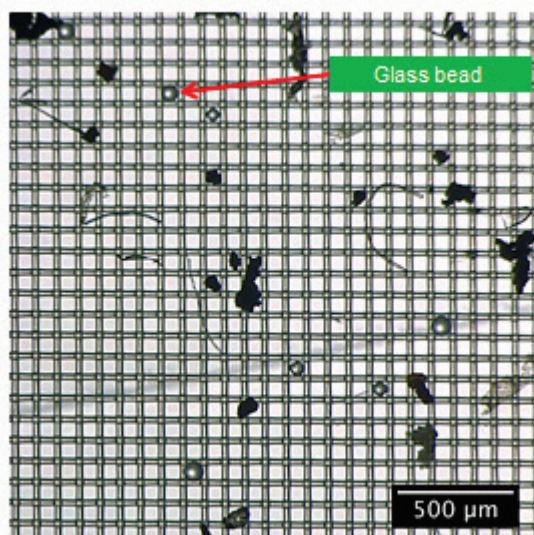
10 beads per view (at x40) equates to 700 for the patch - send for full analysis

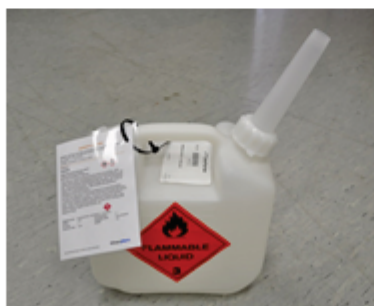
## Secure

- a) Clean funnel & replace dust cap
- b) Empty waste solvent container
- c) Clear counts
- d) Software OFF/ Computer OFF/ Power OFF
- e) Cover microscope
